# Heritage Conservation: Applying Scientific Method in Architecture The Lingayen Capitol Building (1918)

**Rene Luis S. Mata<sup>1</sup>**  
oroplatajo2mata@yahoo.com

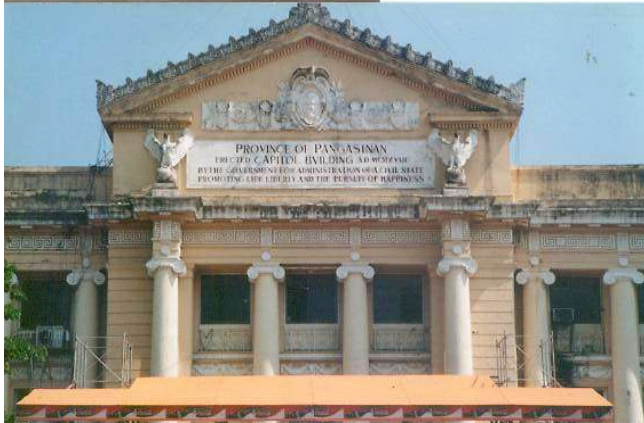
**Figure 2: The Capitol's facade before the restoration project**

The monumental grandeur of the capitol building was ended during the Japanese bombing of the Lingayen during the Second World War. Only the shell of the beautiful building remained after the smoke subsided.

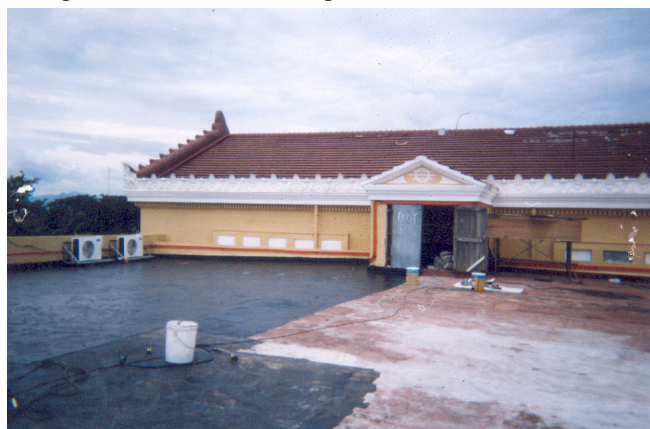
This is to prevent water seepage into the building and to ensure the interior of the building is protected from biological and chemical damage due to unwanted moisture.

**Figure 3: Waterproofing of roofdeck**
