Laboratory Experiments on Steady State Seepage-Induced Landslides Using Slope Models and Sensors

ABSTRACT

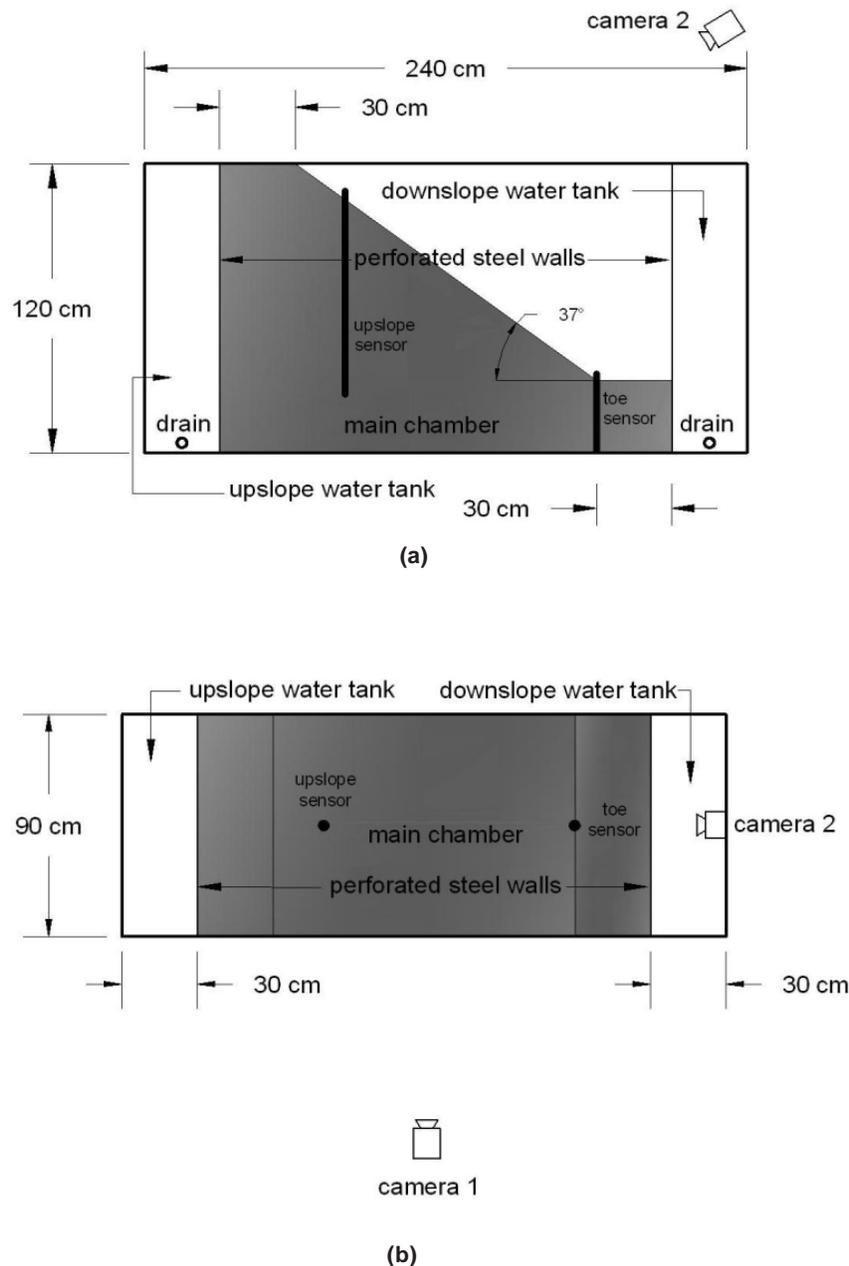
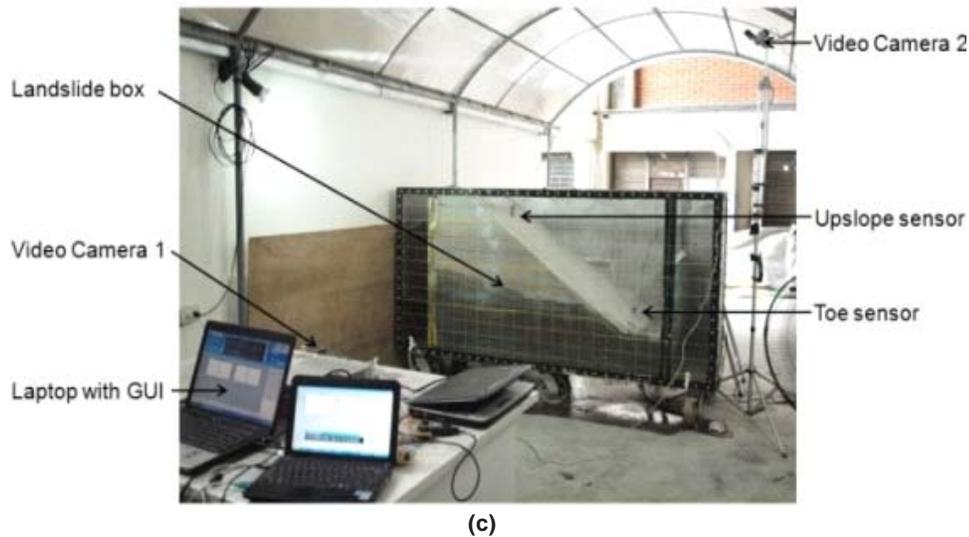
Figure 1. Schematic diagram of the landslide box used in the experiments. (a) section view and (b) plan view. (c) laboratory set-up showing the landslide box, sensors and data acquisition system.

The landslide box, shown in Fig. 1a, is 240 cm long, 90 cm wide and 120 cm high. Its walls, except for one, are made of steel plates. A transparent plexi glass was used in one of the side walls to visually observe changes in the model slope.

The box is divided into three sections: the upslope water tank, the downslope water tank and the main chamber (Fig. 1a). The water tanks are 30 cm x 90 cm while the main chamber is 180 cm x 90 cm. Separating the said chambers are perforated steel walls covered with wire mesh. The walls allow water to pass through without flushing out the sand grains. A plastic hose was used to fill in the upstream water tank. Faucets are installed at the bottom of the water tanks to control water outflow.

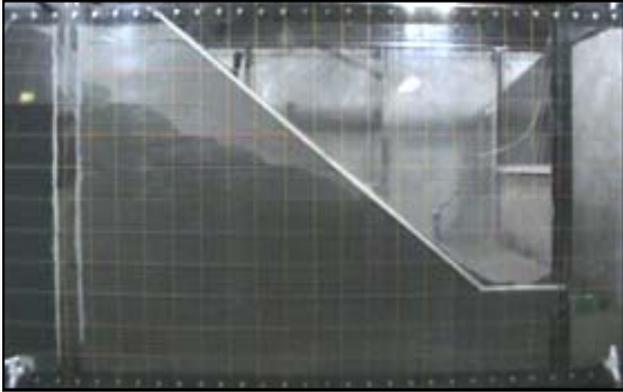
Figure 2. Profile of the asymmetric wetting front at 80 cm water level.

In order to establish the initial conditions, water was allowed to seep through the perforated steel wall and migrate laterally toward the downslope tank, producing a saturation zone. The profile of the wetting front is asymmetric as shown in Fig. 2. A capillary zone has developed adjacent to the upslope tank which resulted to the higher level of the saturation zone than the water

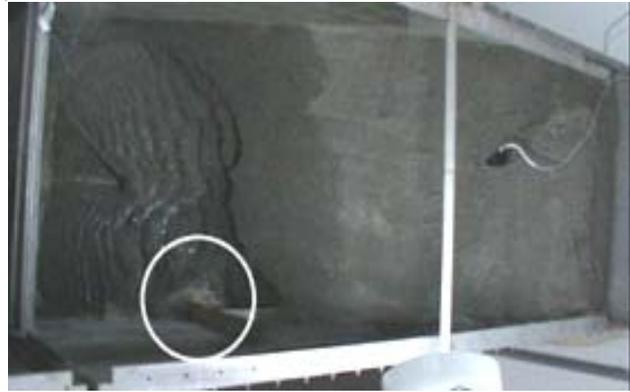
Figure 3. Piping at the toe of the slope model (view from Camera 2).

Piping at the sand/wall interface began at $T_3=53$ min at 90 cm water level (Fig. 3). At $T_4=94$ min, water from the upslope tank flooded the main chamber due to retrogressive failure of the slope.

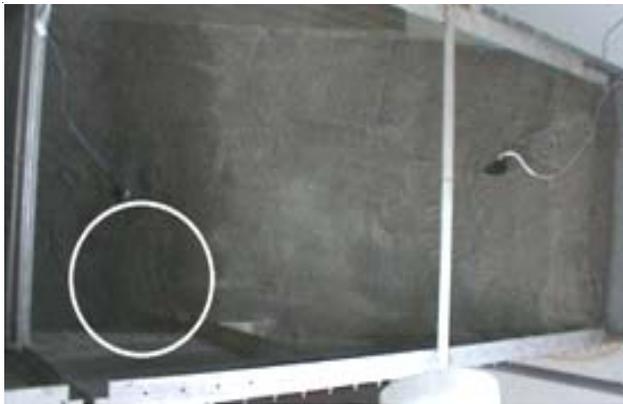
Figure 4. Bulging at the toe (view from Camera 2).

Movement of the soil mass was preceded by the development of bulges or pressure ridges at the toe area at $T_{1d}=21$ min and water level of 61 cm (Fig. 4).

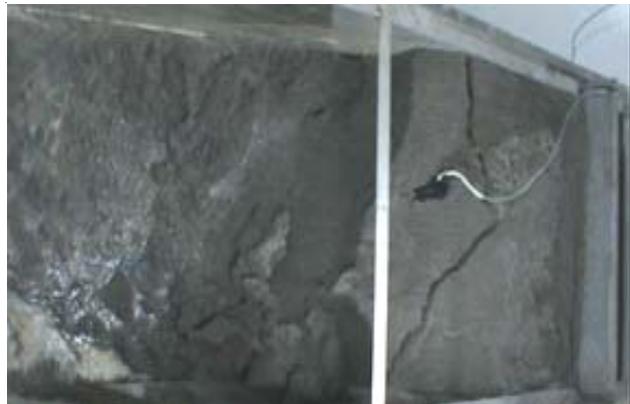
Figure 5. Plan view of the largest tension crack just above the upslope sensor column. (view from Camera 2).

Tension cracks started to form in the unsaturated portions of the slope face. The first tension crack was observed at $T_{3d}=71$ min and a water level of 99 cm. A series of failure occurred along the cracks. The largest tension crack appeared near the head of the slope (Fig 5). The failure of the soil mass along this crack happened at $T_{4d}=81$ min.

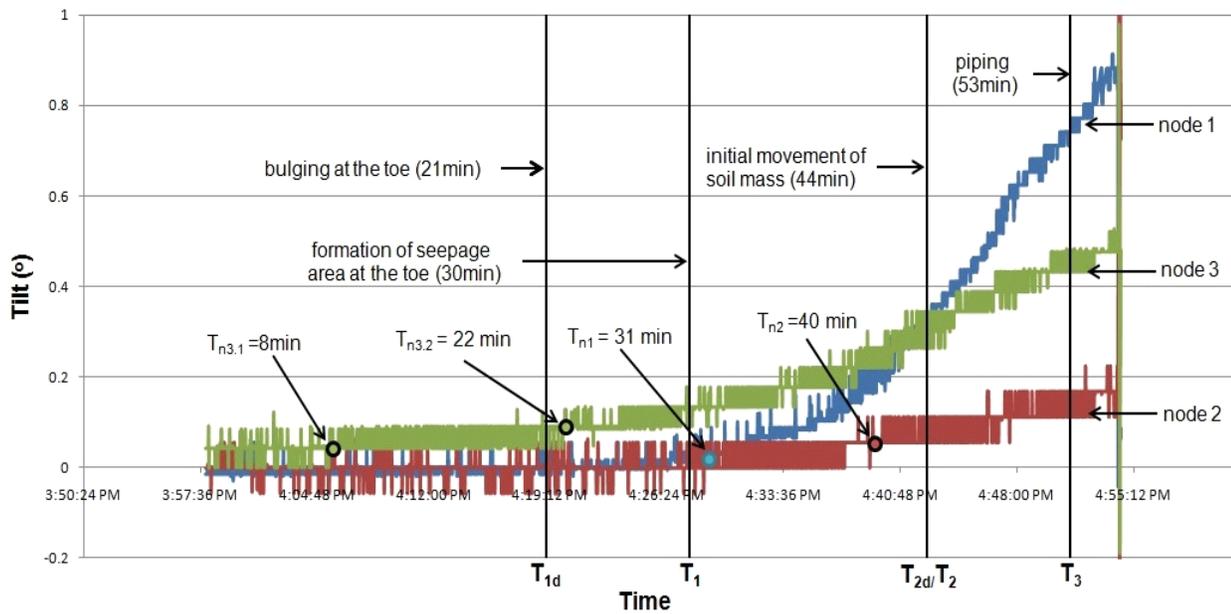
Figure 6. Toe sensor readings. All nodes have positive tilt (node tilts away from the slope).

The nodes in the sensor column installed at the toe area show changes in tilt up to 0.9 deg (Fig. 6). Movements were detected 14 to 22 min prior to the

This condition was first captured by the toe sensor node 3 at $t=30$ min and water level of 70 cm (Fig. 6). The above result justifies the importance of installing sensors at the toe of slopes since they are most sensitive to changes.

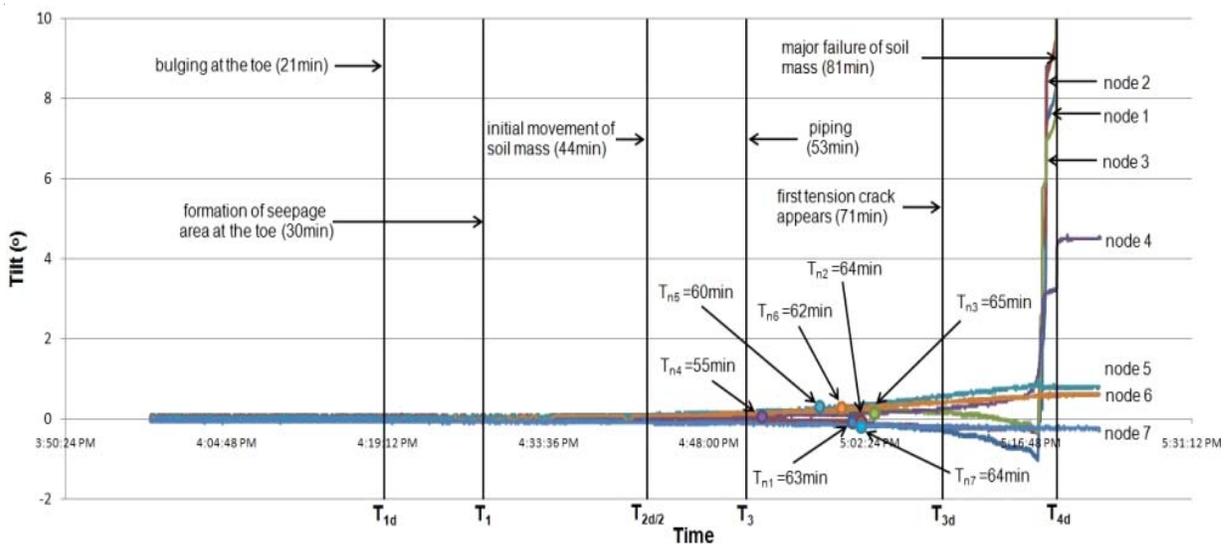
Figure 7. Upslope sensor readings from T_{1d} to T_{4d} . Positive tilt values=node tilts away from the slope; negative tilt values=node tilts towards the slope.

The upslope sensors did not detect any of the earlier movements in the toe area. However, changes were recorded when movements progressed to the upper portion of the slope model but prior to the main failure (Fig. 7).

Initial failure of the toe caused the removal of support and increased the slope angle and consequently resulted to retrogressive failure. The change in tilt in upslope sensor nodes 1 to 7 are all related to retrogressive failure (Fig. 7).

Tension crack is an extension fracture caused by tensile stress. It reduces the overall stability of a slope by decreasing the shear strength. Even before the tension cracks manifested, all nodes in the upslope sensor column have detected change in tilt (Fig. 7).

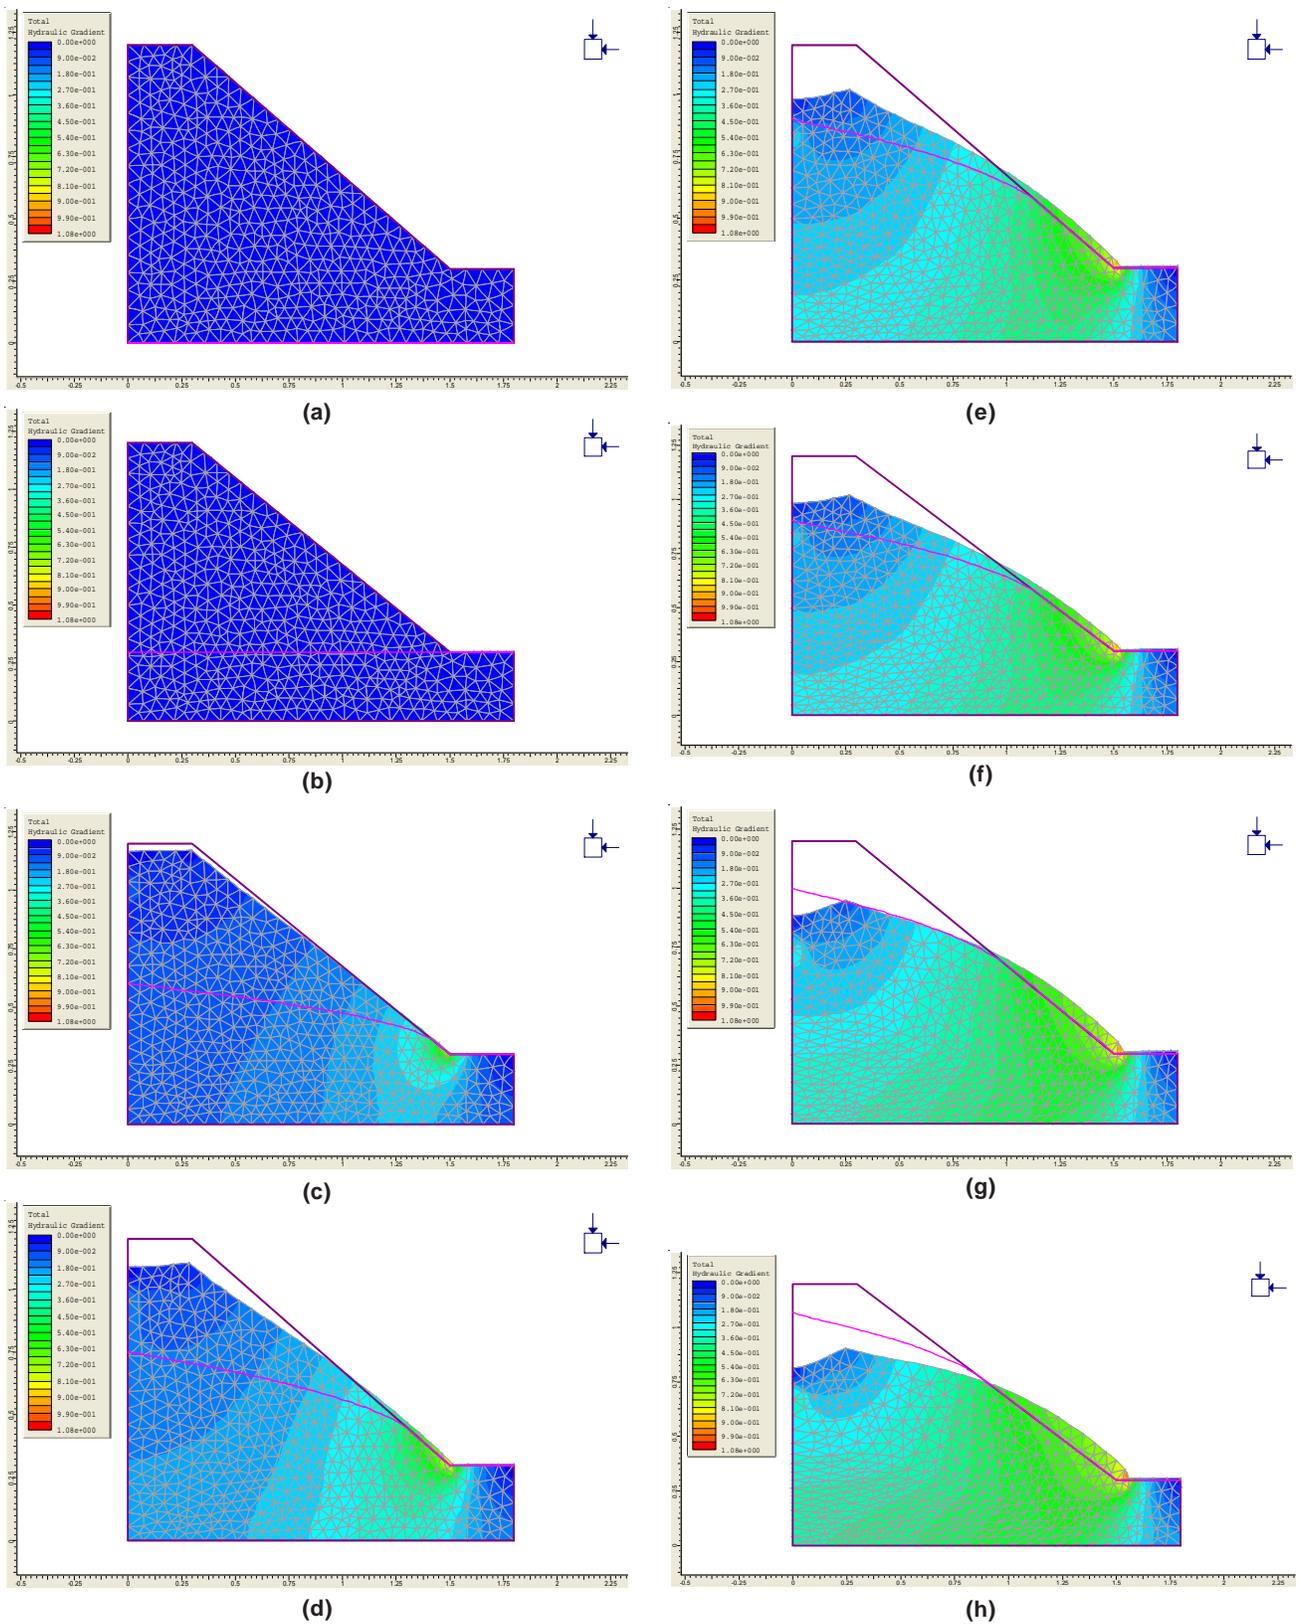
Figure 8. Contour plot showing the change in hydraulic gradient distribution within test embankment with increase in upstream head. (a) Initial gravity load, (b) $h_0=0.3$ m, (c) $h_0=0.6$ m, (d) $h_0=0.75$ m, (e) $h_0=0.9$ m, (f) $h_0=0.95$ m, (g) $h_0=1.0$ m, (h) $h_0=1.07$ m.

Results of the analyses for each stage are illustrated in Fig 8. As shown in the figures, progressive saturation of the slope results in a vertical downward displacement of the top of the slope, followed by lateral bulging at the toe of the slope beginning at $h_0 = 0.75$ m (Fig. 8d). The bulging continued to increase as the head in the upstream water tank was increased until failure occurred at $h_0 = 1.07$ m (Fig. 8h). The bulging continued to increase as the head in the upstream water tank was increased until failure occurs at $h_0 = 1.07$ m (Fig. 8h). Also noticeable was the development of very high hydraulic gradients in a localized zone at toe area of the slope which indicates the presence of large seepage forces locally occurring in this area. During numerical experiment, the hydraulic gradient in the toe zone has

Finite element modeling predicted the very high hydraulic gradients (Fig. 8) rather than the reduction of shear strength resulting from high pore pressures as the main mechanism for failure. High hydraulic gradients are physically manifested by pressure ridges, seepage and surface erosion. The modeling confirms that the appropriate site for installation of monitoring instrument and sensors is the toe area to capture the changes in hydraulic gradients.

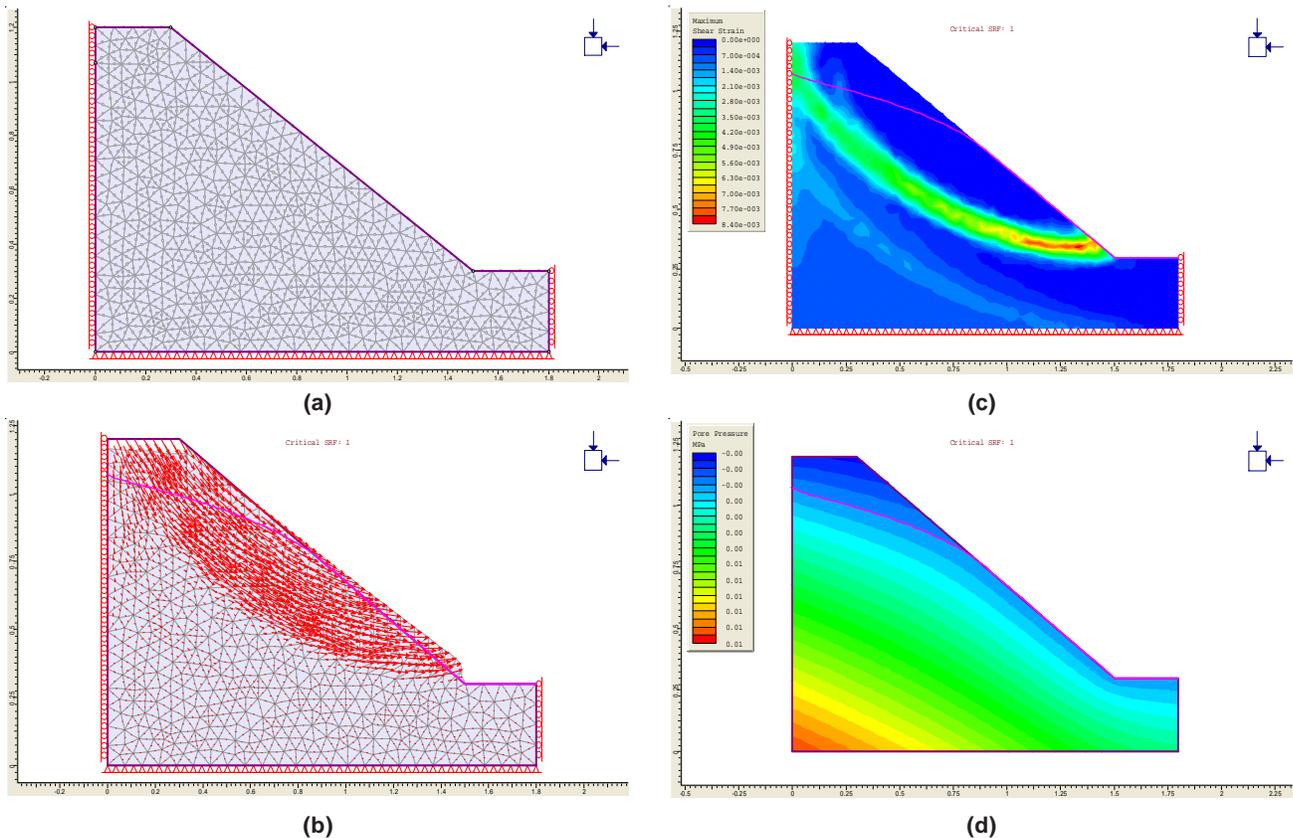
Figure 9. Results of finite element analysis of landslide box experiment summarizing conditions at failure. (a) finite element mesh, (b) deformed mesh and displacements vectors at failure, (c) contour plot of shear strain profile at failure, (d) contour plot of pore pressures at failure.

Figure 9 illustrates the predicted conditions within the slope during failure at $h_0 = 1.07$ m. The finite element mesh together with the enforced boundary seepage and deformation boundary conditions is shown in Fig. 9a. Figure 9b shows the corresponding deformed mesh and displacement vectors at the initiation of failure, while Fig. 9c is a contour plot showing the variation of the shear strain within the slope during failure. Figures 9b and 9c indicate a rotational type failure for the slope. Figure 9d is a contour plot of the pore pressure distribution within the slope. Comparing this figure with corresponding Fig 8h, failure in the slope occurs primarily due to high hydraulic gradients that resulted in large seepage forces, rather than the decrease of shear strength resulting from high pore pressures.
